# WATER QUALITY MONITORING PROJECT FOR DEMONSTRATION OF CANAL REMEDICATION METHODS: FLORIDA KEYS

Final Report

May 2018

Submitted by: **Henry O. Briceno**  
Southeast Environmental Research Center  
Florida International University  
Miami, Florida

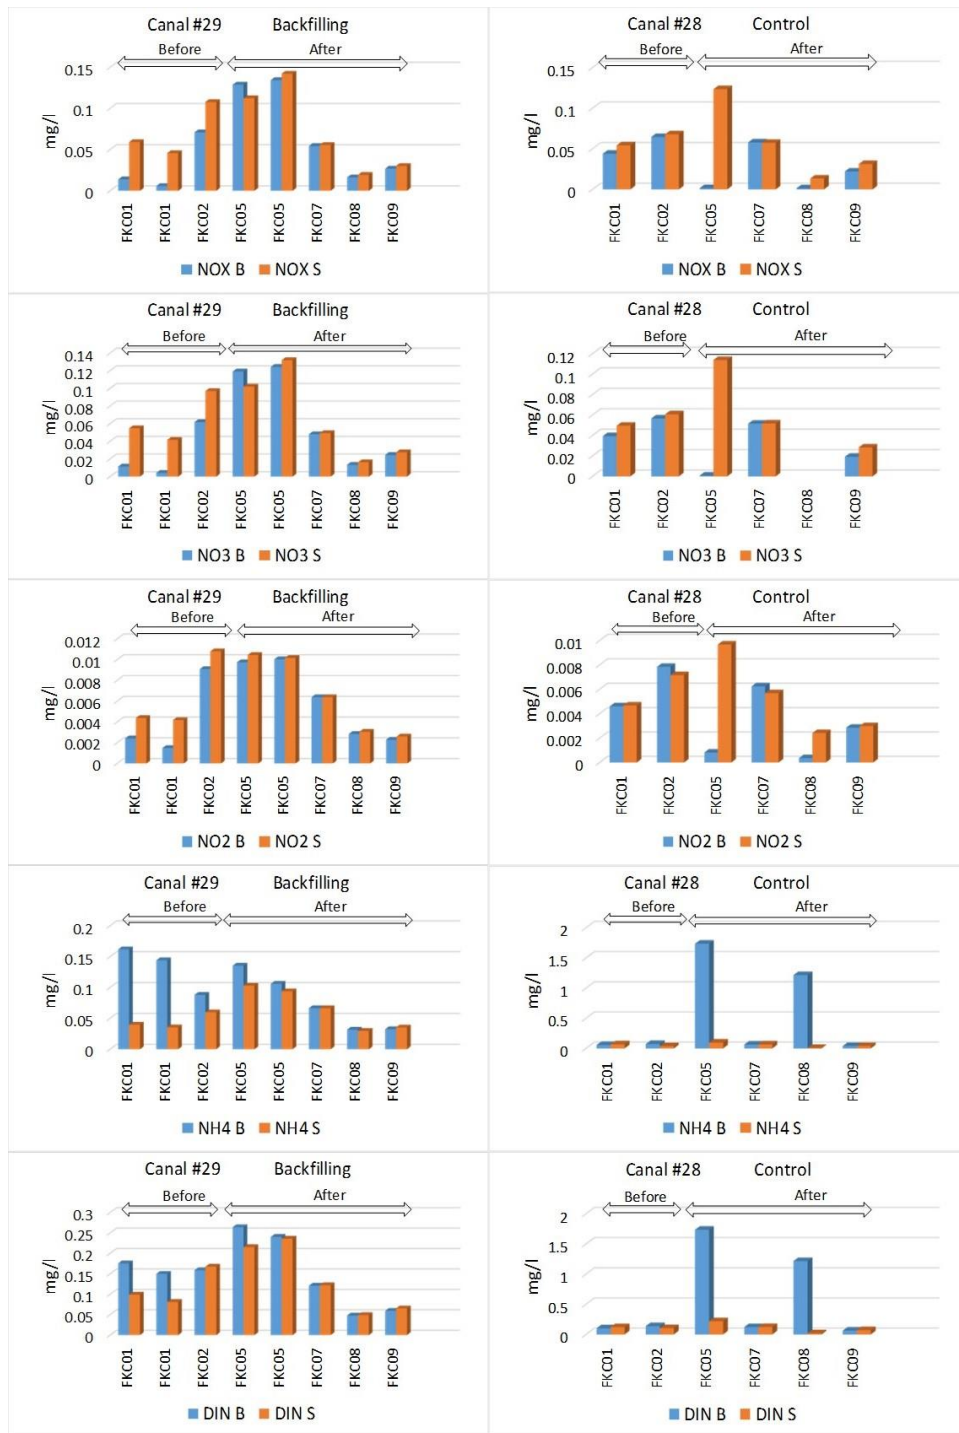
NO<sub>2</sub>, NO<sub>3</sub>, NO<sub>x</sub>, and DIN seem to decline AFTER remediation (after FKC05; Fig 6.1.3) and it is a good sign, but this decline is also evident in the control canal, and there were similar concentrations pre-remediation. So, those declines cannot be exclusively ascribed to remediation. NH<sub>4</sub> clearly declined after remediation for bottom samples as expected. TN and TON have not improved AFTER backfilling (Fig 6.1.4), and declines in TP and SRP are somehow mimicked in the control canal, ruling out remediation as the exclusive cause of reduction in

**Fig 6.1.3.** Water quality comparison between Before and AFTER sampling, and between remediated Canal #29 and control Canal #28. Dissolved nitrogen species: nitrate+nitrite (N+N), nitrate (NO<sub>3</sub>), nitrite (NO<sub>2</sub>), ammonium (NH<sub>4</sub>) and dissolved inorganic nitrogen (DIN)

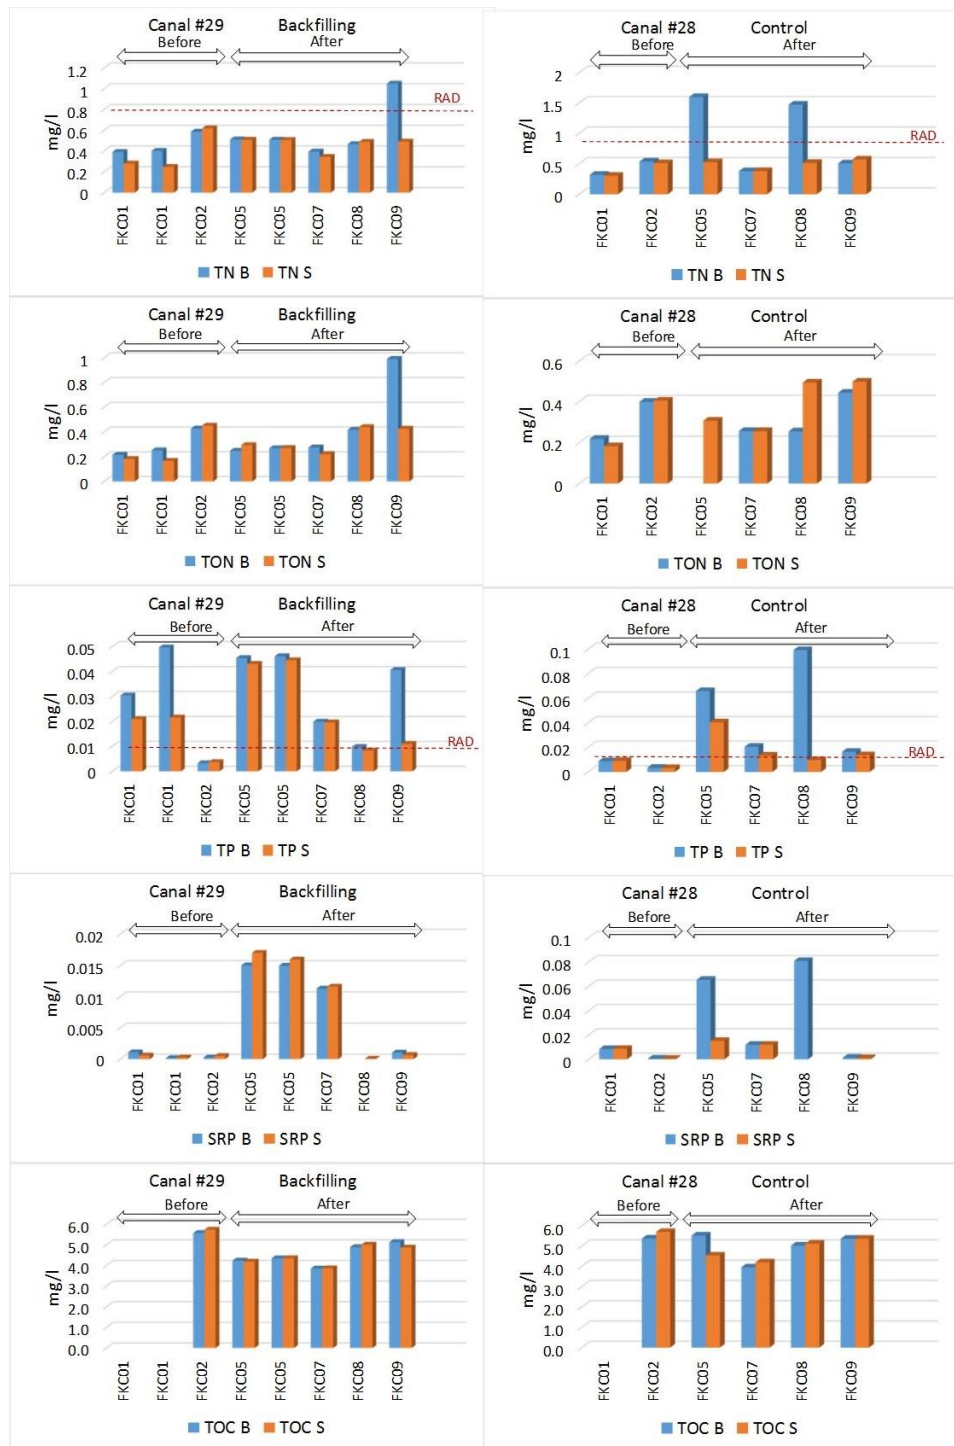
**Fig 6.1.4.** Water quality comparison between Before and AFTER sampling, and between remediated Canal #29 and control Canal #28. Dissolved nitrogen species: total nitrogen (TN); total organic nitrogen (TON); total phosphorous (TP); soluble reactive phosphorous (SRP); and total organic carbon (TOC).

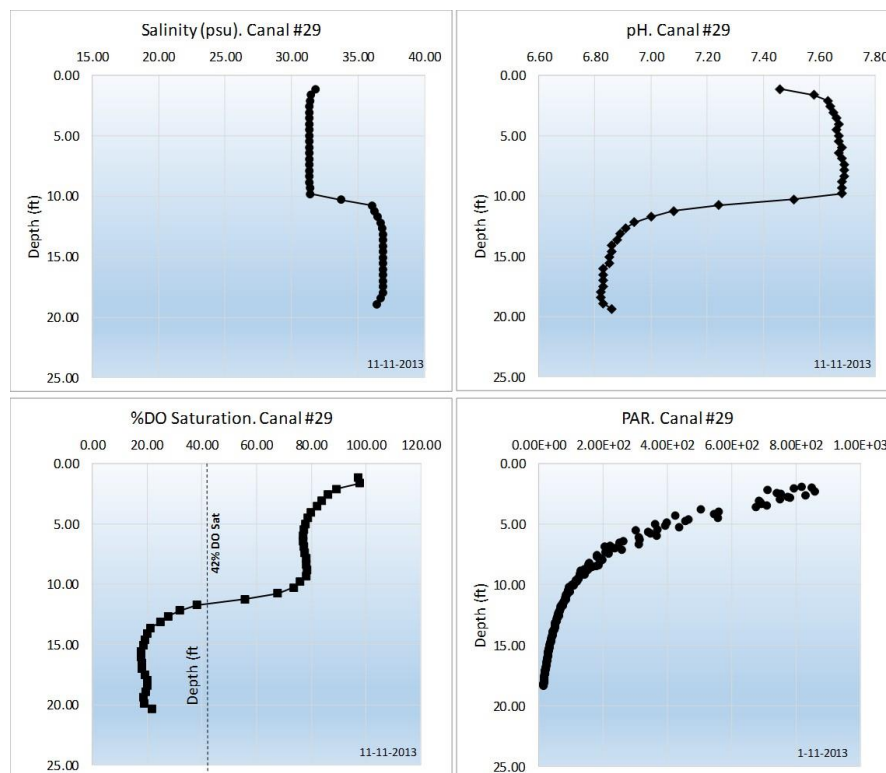
**Figure 6.1.5.** Profiles of physical-chemical variables of water column in Canal #29, measured before backfilling in Nov 2013. Stratification (layering) of water column is well developed

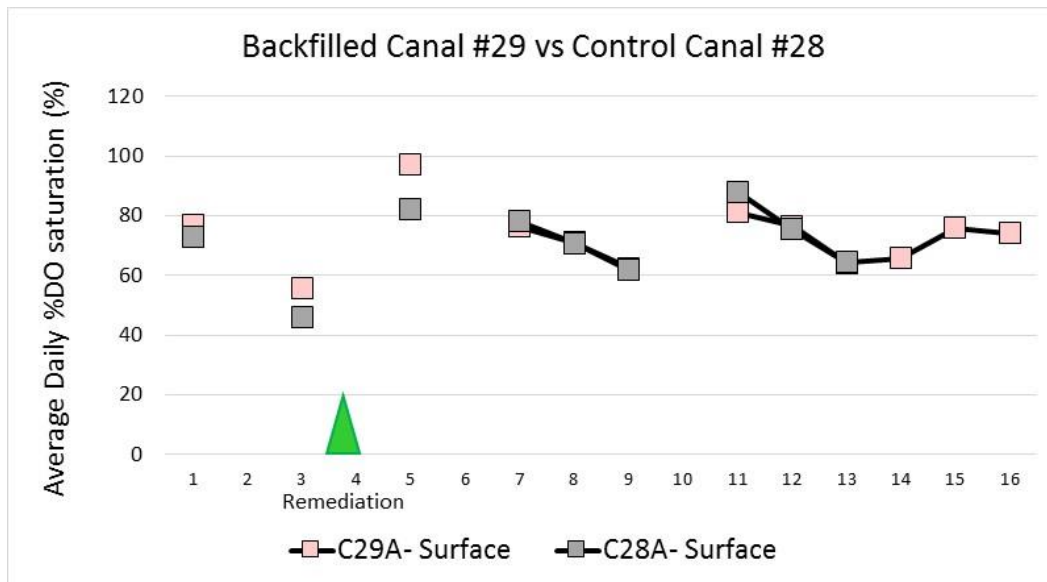
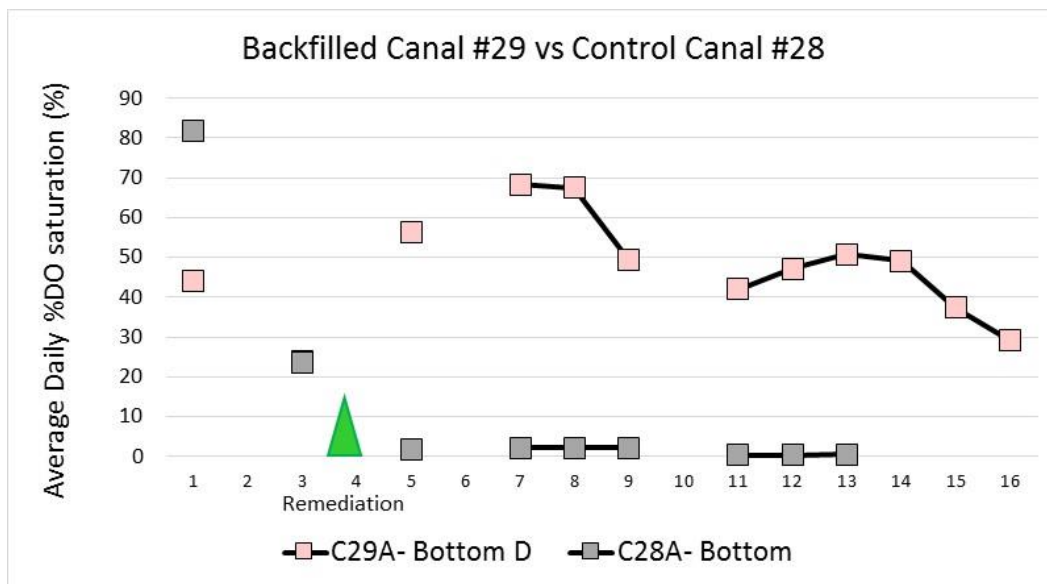
Now, the lower diagram in Fig 6.1.7 show two separate behaviors. Before remediation #29 had lower %DO sat than #28 and after backfilling #28 totally decouples and contains an order of magnitude more %DO saturation than the control canal, and most “diel days” were above 42%. The improvement of water quality conditions of Canal #29 after remediation is evident.

**Figure 6.1.7.** Diel (24 hour) observations of %DO saturation for Backfilled Canal #29 and Control Canal #28, Key Largo. Green triangle indicates when remediation took place.

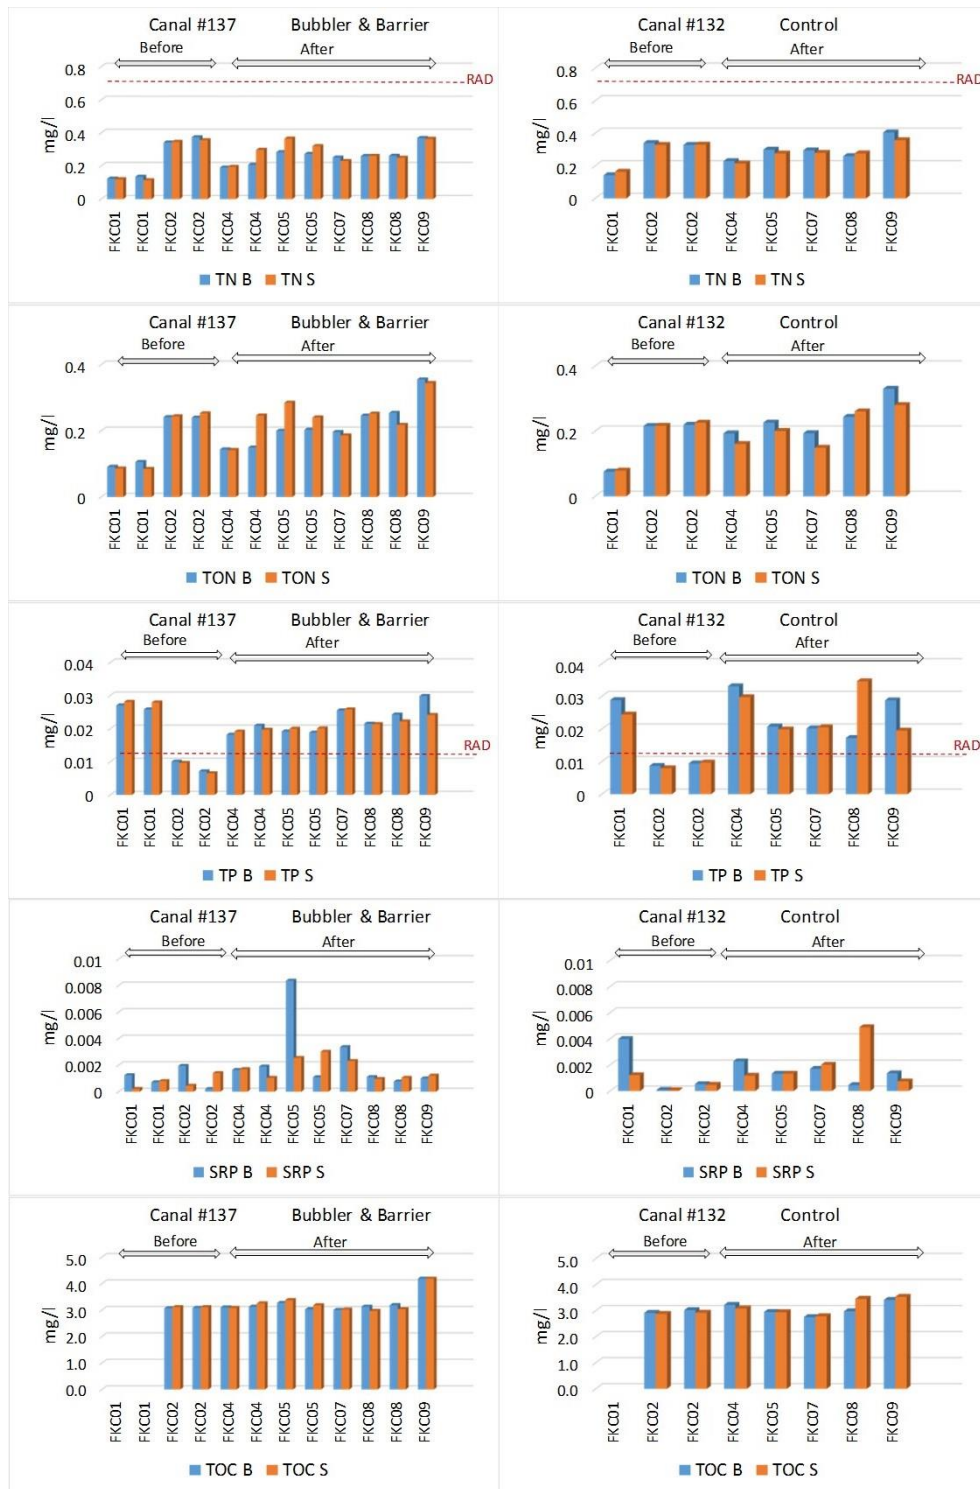
**Fig 6.2.5.** Water quality comparison between Before and AFTER sampling, and between remediated Canal #137 and control Canal #132. Dissolved nitrogen species: total nitrogen (TN); total organic nitrogen (TON); total phosphorous (TP); soluble reactive phosphorous (SRP); and total organic carbon (TOC). Survey FK009 occurred after Irma

TN and TON have not improved after installation of aerators (Fig 6.2.5), and declines in TP and SRP, especially in FKC08 and 09 are somehow mimicked in the control canal, ruling out remediation as the exclusive cause of reduction in concentration. Finally, TOC has remained constant through the whole period of record. In summary, there is an ill-defined pattern of improvement in nutrient data after remediation, and dissolved nitrogen species, especially  $\text{NH}_4$  and DIN, seem to be moving in the right direction in Canal #137.

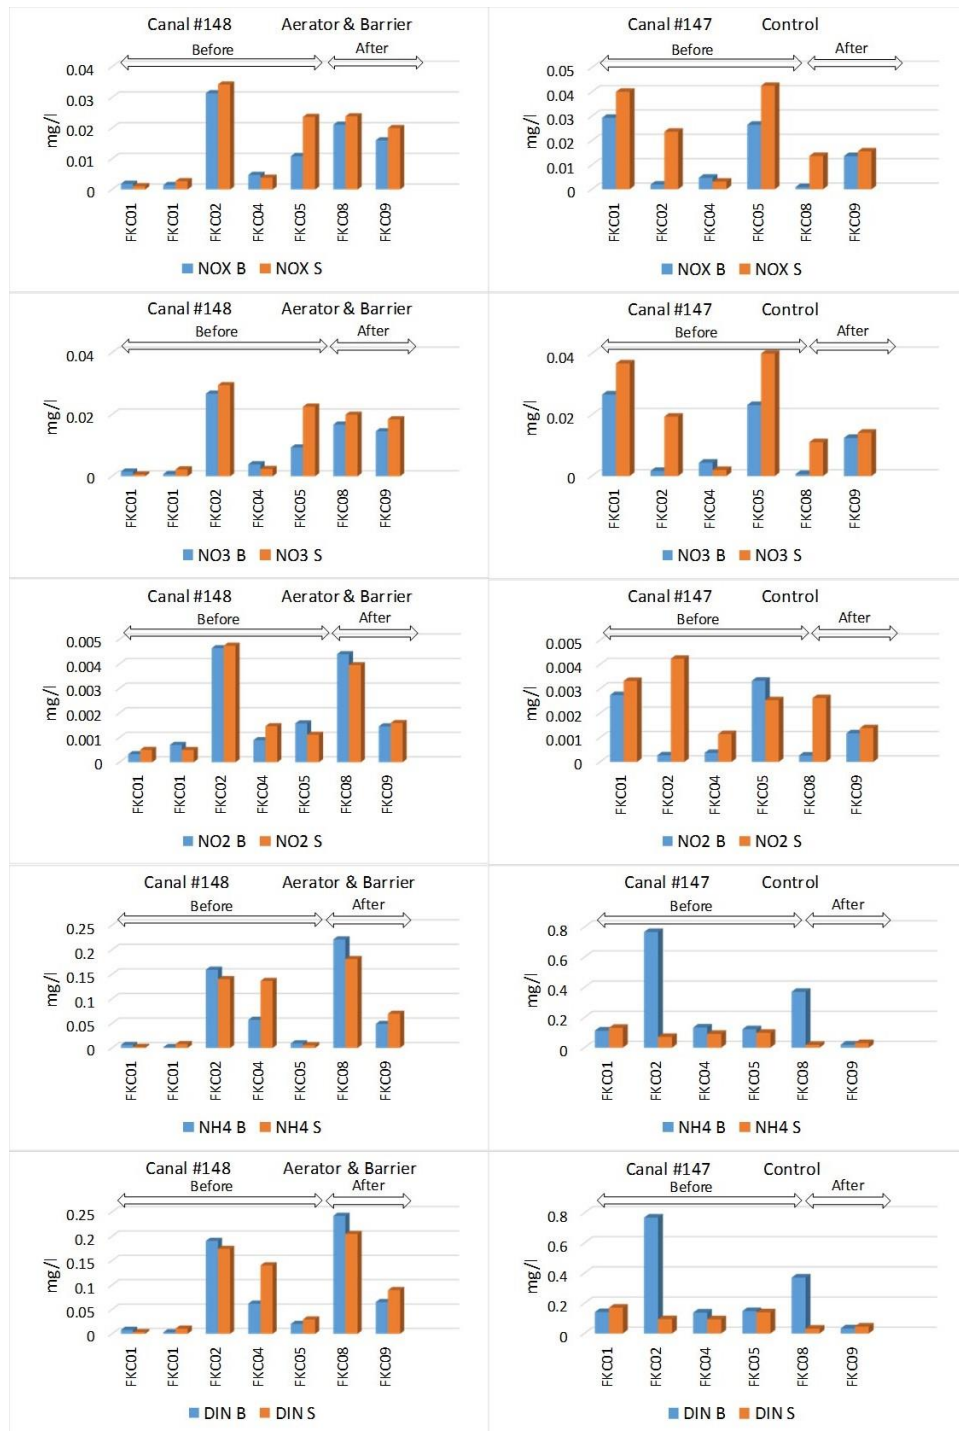
NO<sub>3</sub>, NO<sub>x</sub>, NO<sub>2</sub>, NH<sub>4</sub>, DIN do not show significant changes after remediation, except for some occurring after Irma's impact (FKC09; Fig 6.3.4), which cannot be ascribed to a differential response to Irma due to remediation, because similar changes are also observed in the control canal data. As shown in Figure 6.3.5, TN, TON, TP and SRP are non-diagnostic either. Finally, TOC has remained constant through the whole period of record. In summary, there is not clear pattern of improvement in nutrient data AFTER remediation. Not enough samples have been

**Fig 6.3.4.** Water quality comparison between Before and AFTER sampling, and between remediated Canal #148 and control Canal #147. Dissolved nitrogen species: nitrate+nitrite (N+N), nitrate (NO<sub>3</sub>), nitrite (NO<sub>2</sub>), ammonium (NH<sub>4</sub>) and dissolved inorganic nitrogen (DIN). Survey FKC09 occurred after Irma.

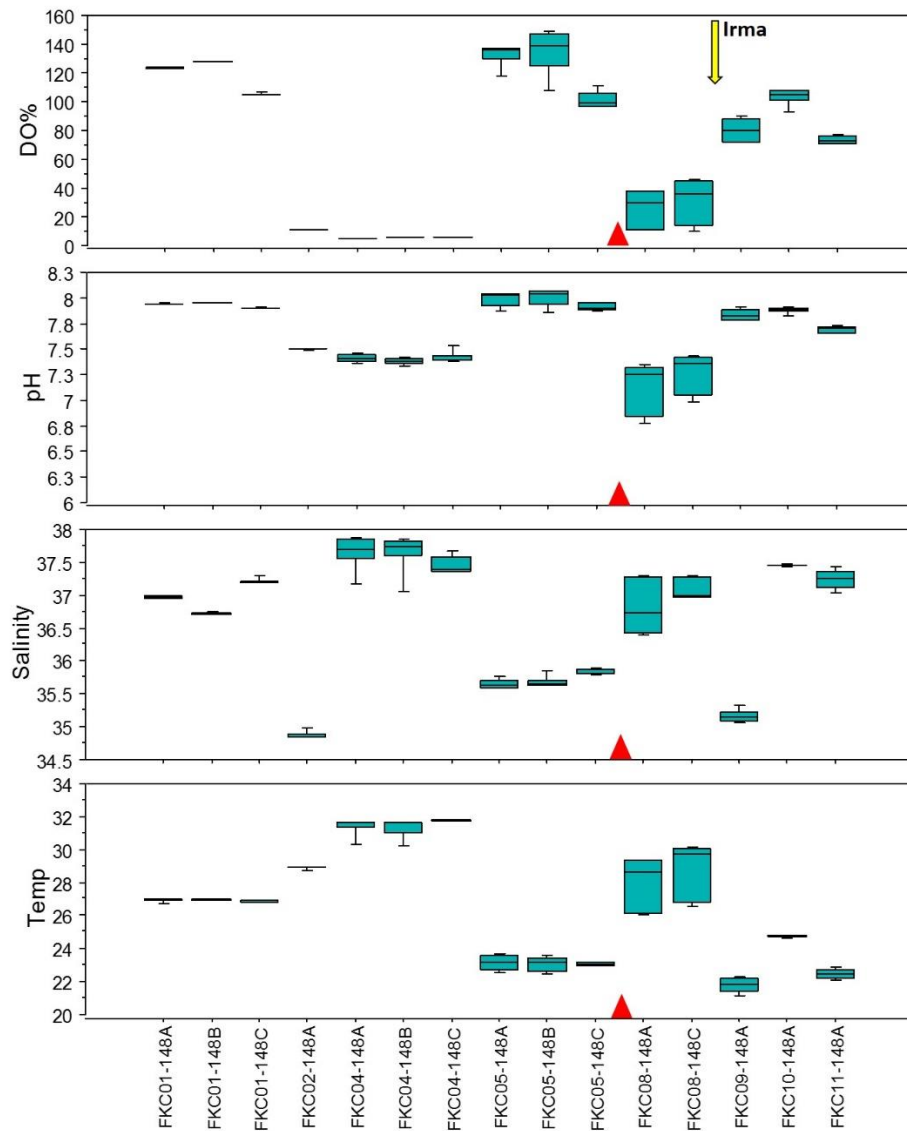
Before remediation, variability of median %DO sat was extreme, from practically anoxic condition at 4.8% to oversaturation around 138%. The occurrence of these extremely high %DO sat values is not a sign of good water quality, on the contrary, the cause of those extremely high values is a overwhelming abundance of planktonic organisms (dinoflagellates?), which generate abundant oxygen during sunny days but consume whatever oxygen is in the water column during night respiration (Haraguchi et al. 2010) as we will see when discussing diel data. After installation of the weed barrier median saturation values ranged from 30% to 105%, a more adequate regime for sustaining healthy aquatic life.

**Figure 6.3.6.** Box-and-Whisker plots of physical-chemical variables measured along depth profiles of the water column in Canal #148. Date of remediation is indicated by the red triangle.

In summary, water quality as represented by casts of physical-chemical properties in Canal #148 do not suggest improvement in water quality after installation of weed barriers. Nevertheless, as this report is being written, given that hurricane Irma damaged the air curtain system and it has not been repaired, a massive amount of seaweed invaded Canal #148 causing a major fish-kill.

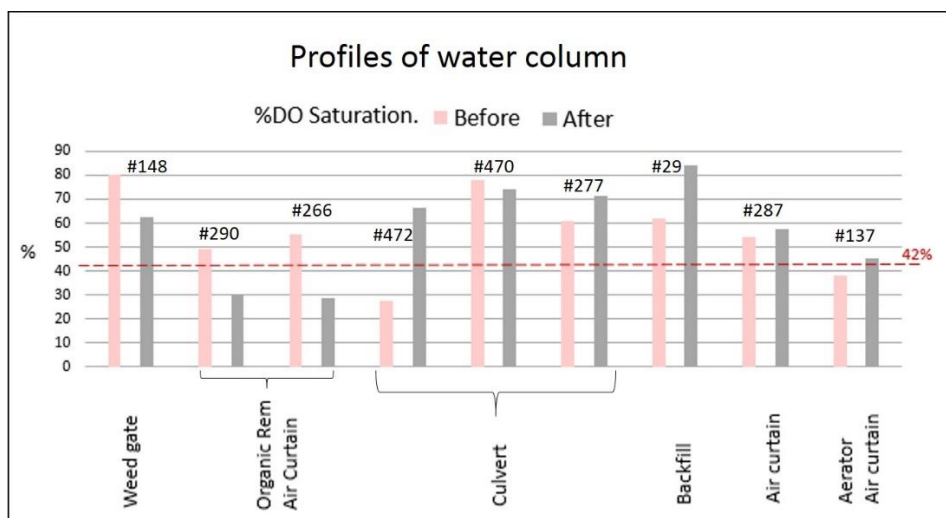
Emphasis was focused on profiles and diel logs because parameters like DO, %DO saturation and pH respond faster to induced changes. As expected, nutrients were the most resilient to changing conditions while diel and profile measurements were the most sensible. Diel and profiles indicate that backfilling and culvert installation are the remediation methods driving fastest positive response of the water column (Fig 7.2). Aeration in canal #137 is also beginning to show increases in %DO Sat.

**Figure 7.2.** Summary of changes in Dissolved Oxygen Saturation in the water column of remediated canals. Red stippled line marks the 42% DO Saturation limit, below which conditions are not appropriate for development of aquatic life.
