*Southeast Environmental Research Center, OE-148
Florida International University, Miami, FL 33199
305-348-3095, 305-348-4096 fax*

Re: Little Venice Water Quality Monitoring Quarterly Reports #6

Project Background

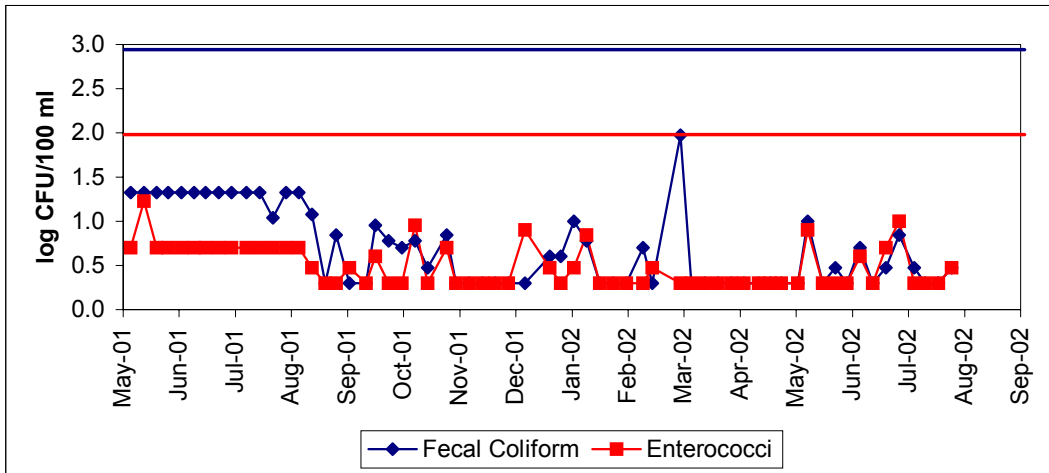
Figure 2

Sta 2 - Nearshore of 100th Street Canal

Figures 2-10 show bacterial counts for the canal stations for the complete period of record. The FL state standard for fecal coliforms in bathing waters using a 30 day running geometric mean is 200 counts/100ml and 35 counts/100ml for enterococci. Fecal coliform counts exceeded the standard 0 times while enterococci counts exceeded standards 23 times over the period of record.

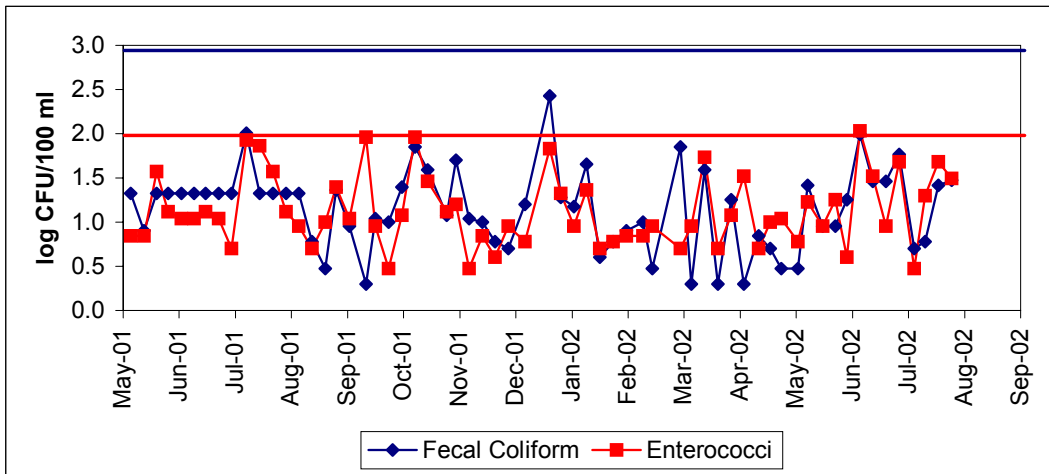
Figure 3

Sta 1 - Mouth of 112th Street Canal

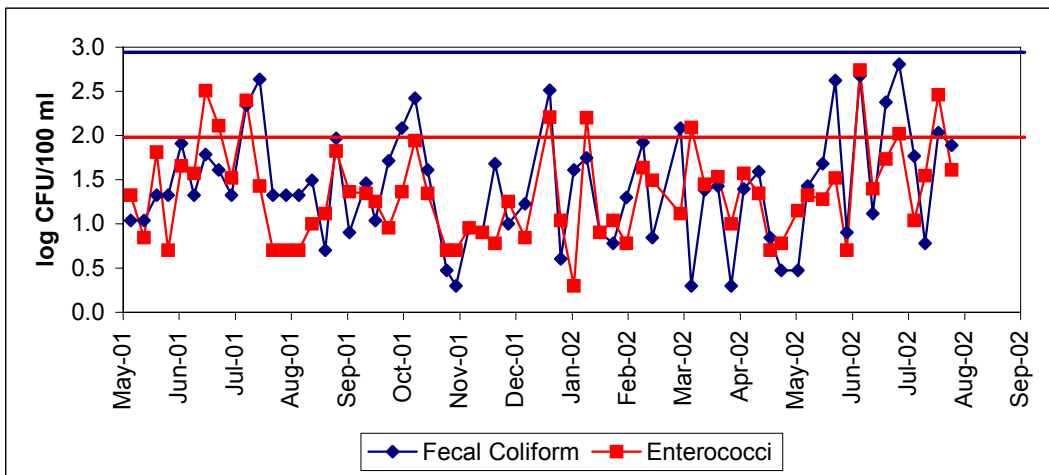
Figure 4

Sta 3 - Head of 112th Street Canal

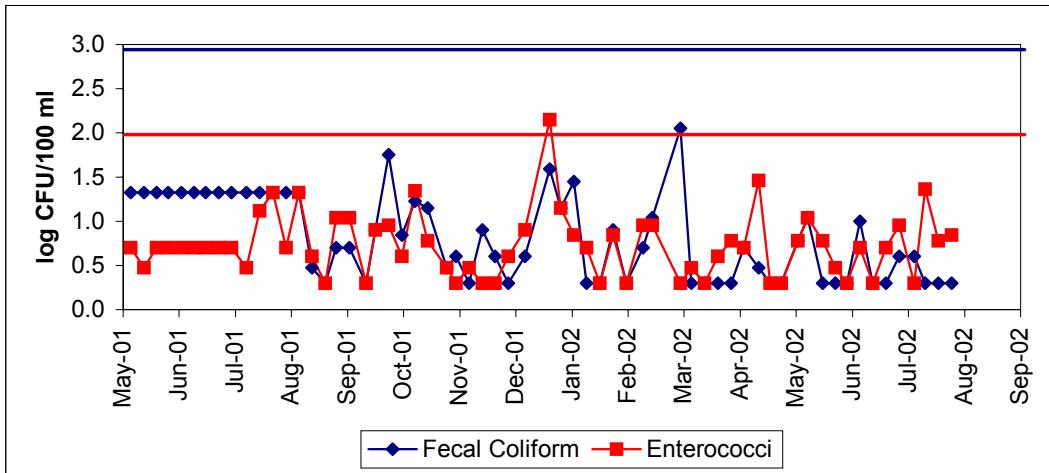
Figure 5

Sta 4 - Mouth of 100th Street Canal

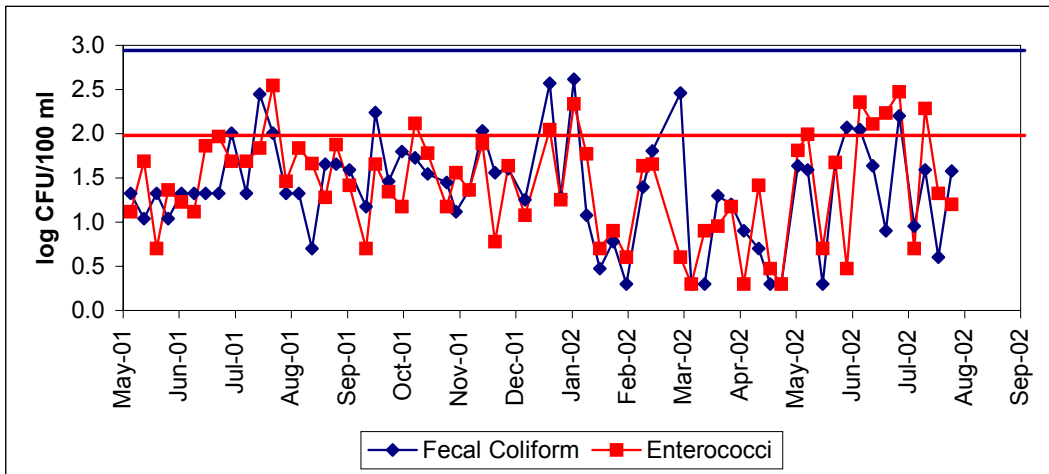
Figure 6

Sta 5 - Head of 100th Street Canal

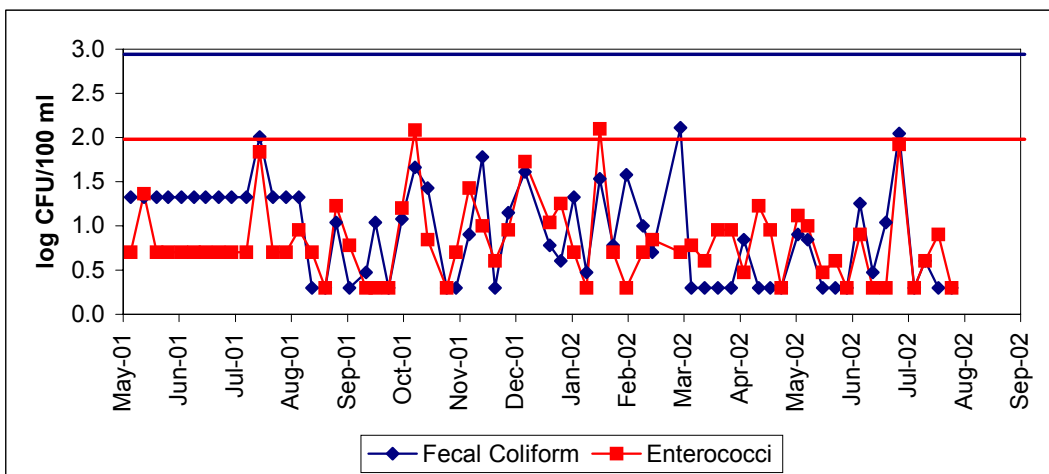
Figure 7

Sta 6 - Mouth of 97th Street Canal

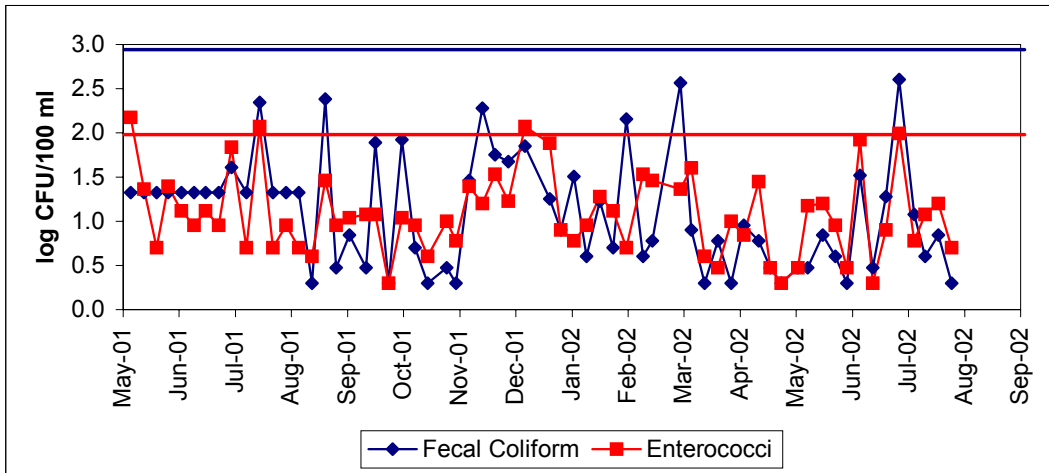
Figure 8

Sta 7 - Head of 97th Street Canal

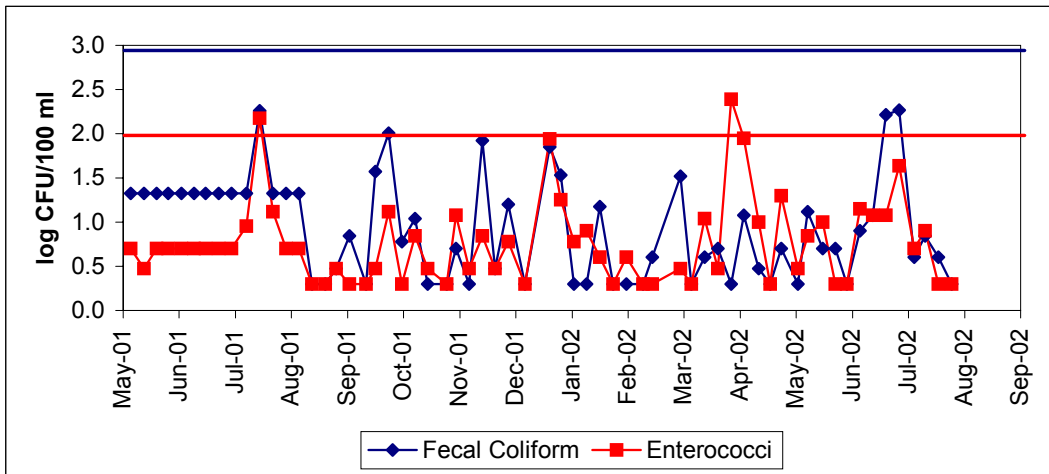
Figure 9

Sta 8 - Mouth of 91st Street Canal

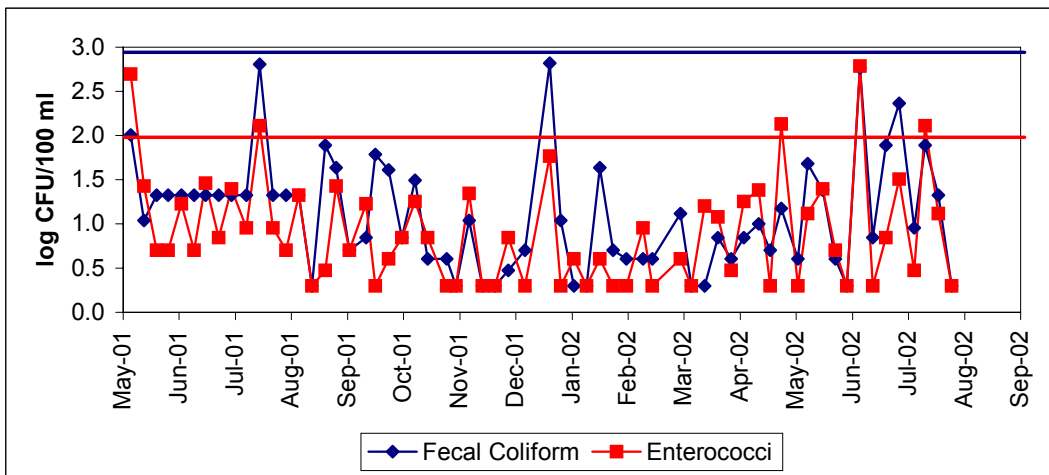
Figure 10

Sta 9 - Head of 91st Street Canal

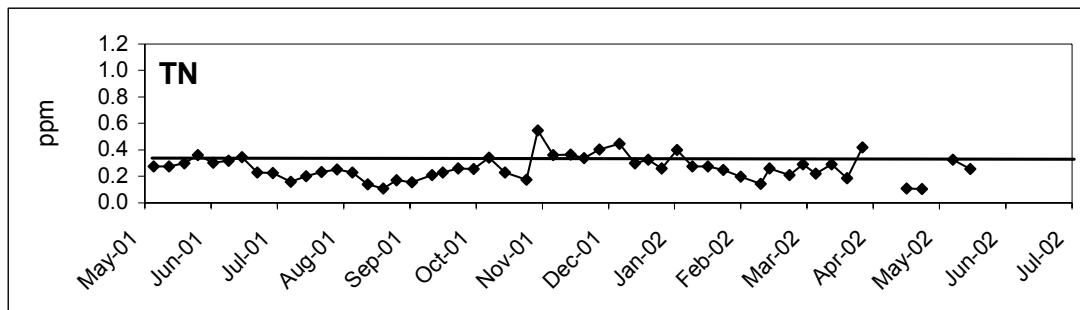
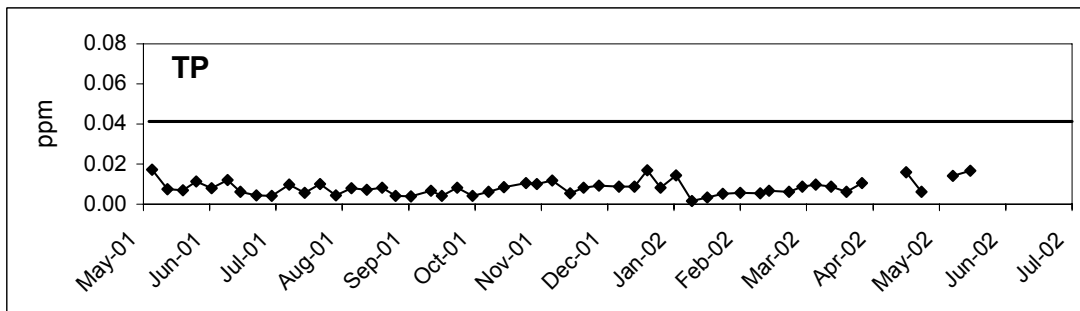
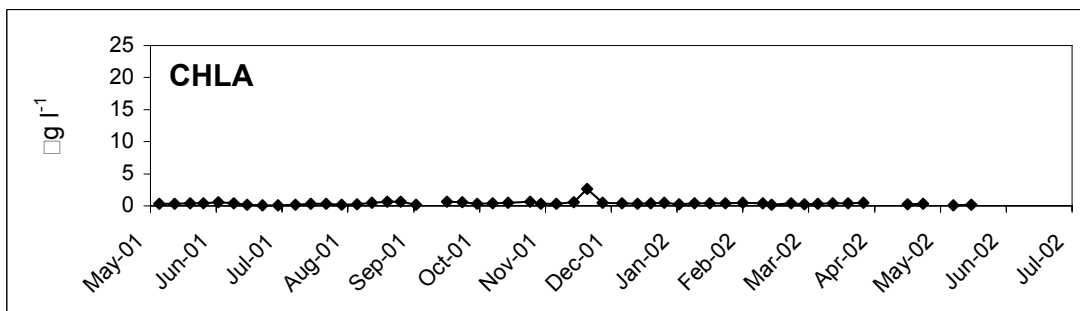
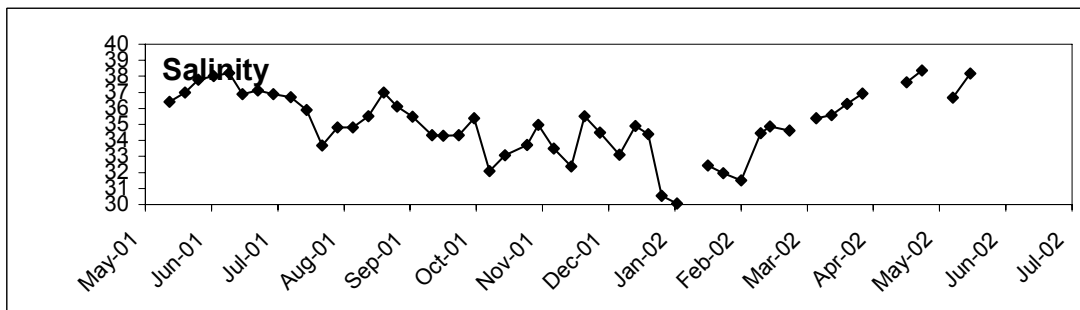
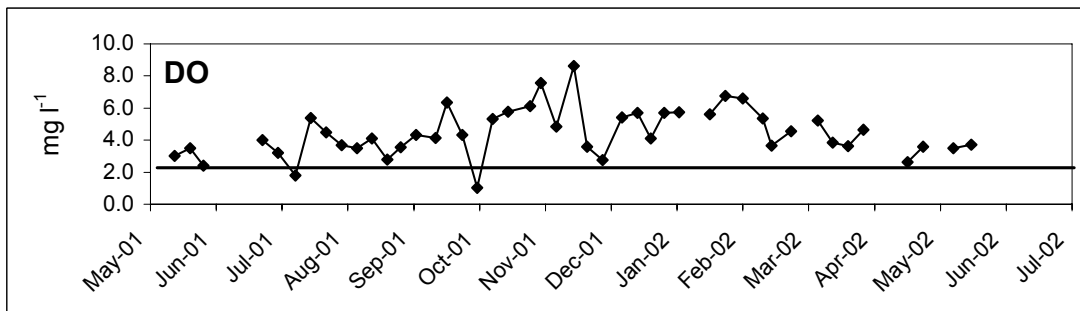
Figure 11

Sta. 1 - Mouth of the 112th Street Canal

Figures 11-19 show time series of TN, TP, CHLA, salinity, and DO at all stations. The heads of the canals generally have the highest TN, TP and CHLA (Fig. 20) but lowest DO (Fig. 21). All are higher than the nearshore site. As to nutrient criteria, there is no standard for Florida marine waters. However, State of Florida Rule 62-302.300(13), F.A.C. states that “particular consideration shall be given to the protection from nutrient enrichment of those presently containing very low nutrient concentrations: less than 0.3 milligrams per liter total nitrogen or less than 0.04 milligrams per liter total phosphorus.” Therefore, these benchmarks are included in the TN and TP graphs for illustrative purposes only.

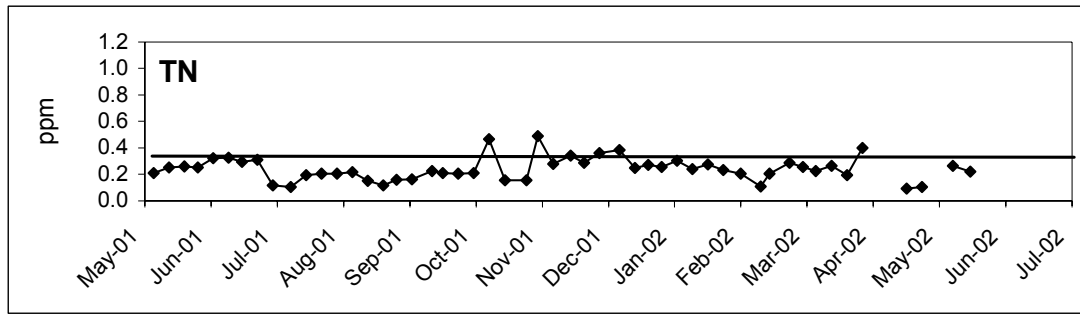
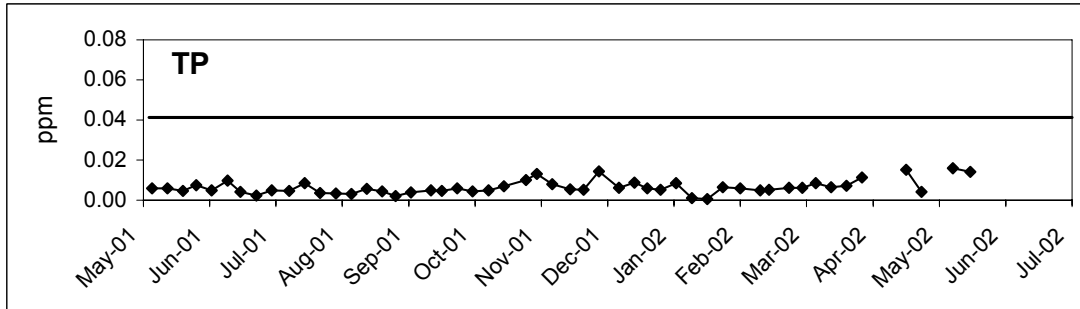
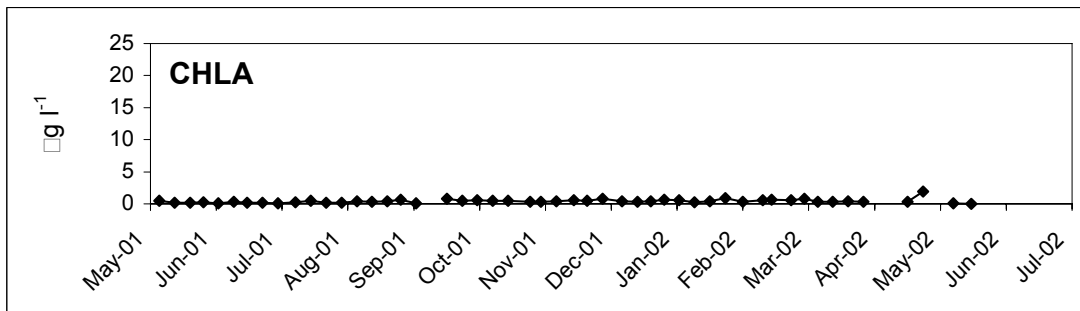
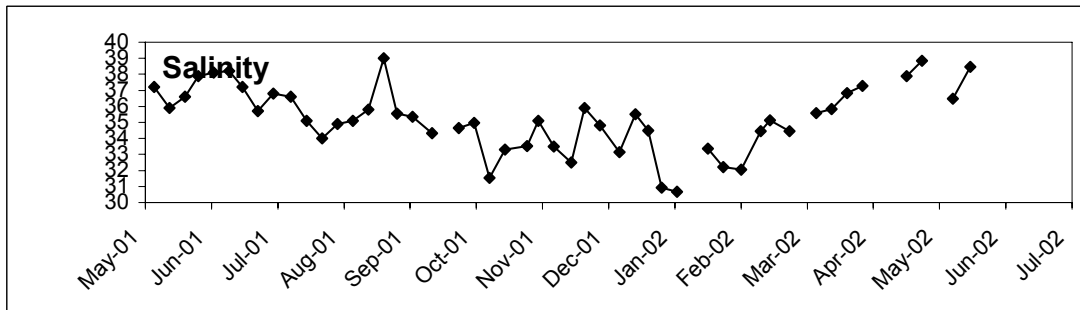
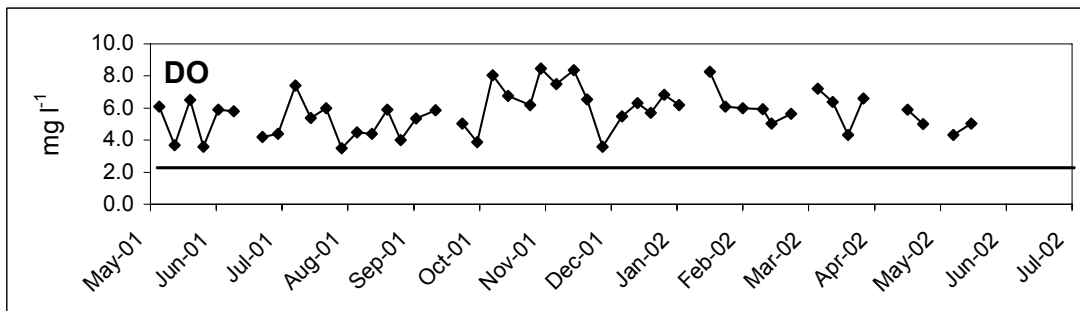
Figure 12

Sta.2 - Nearshore the 100th Street Canal

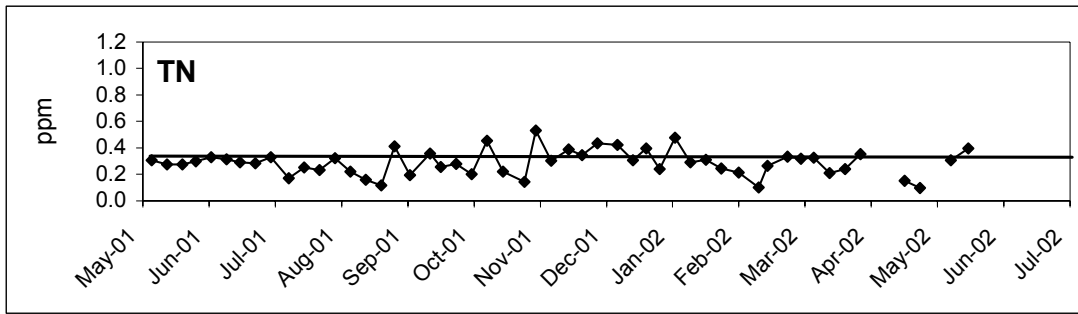
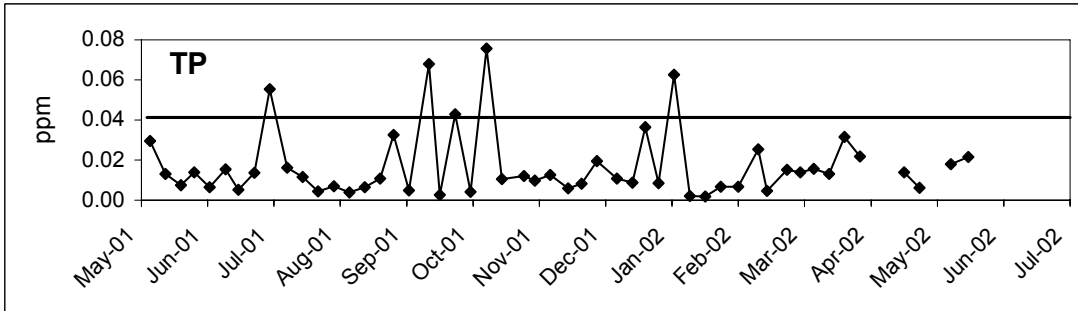
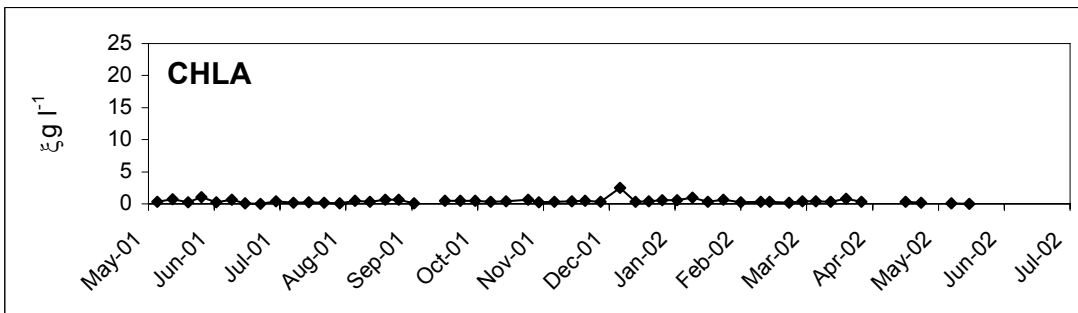
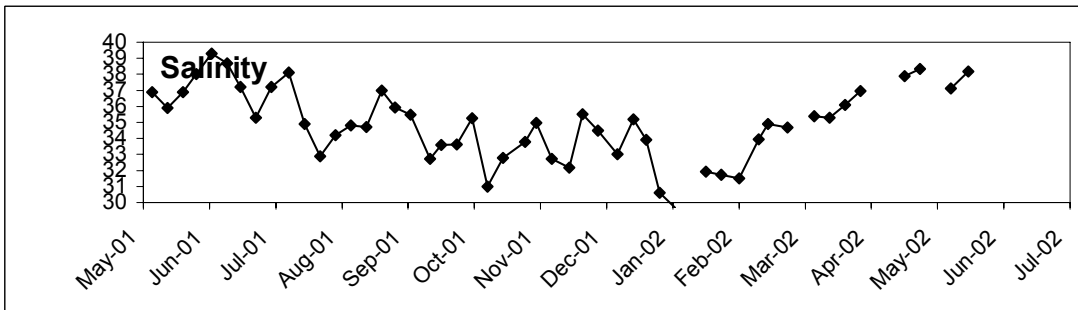
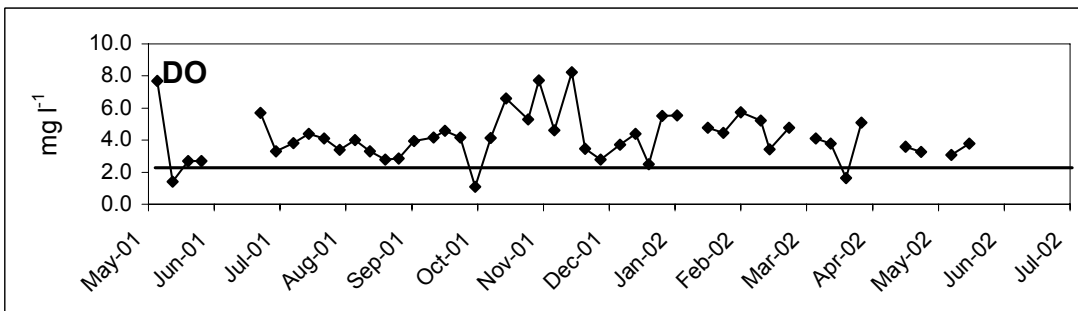
Figure 13

Sta.3 - Head of the 112th Street Canal

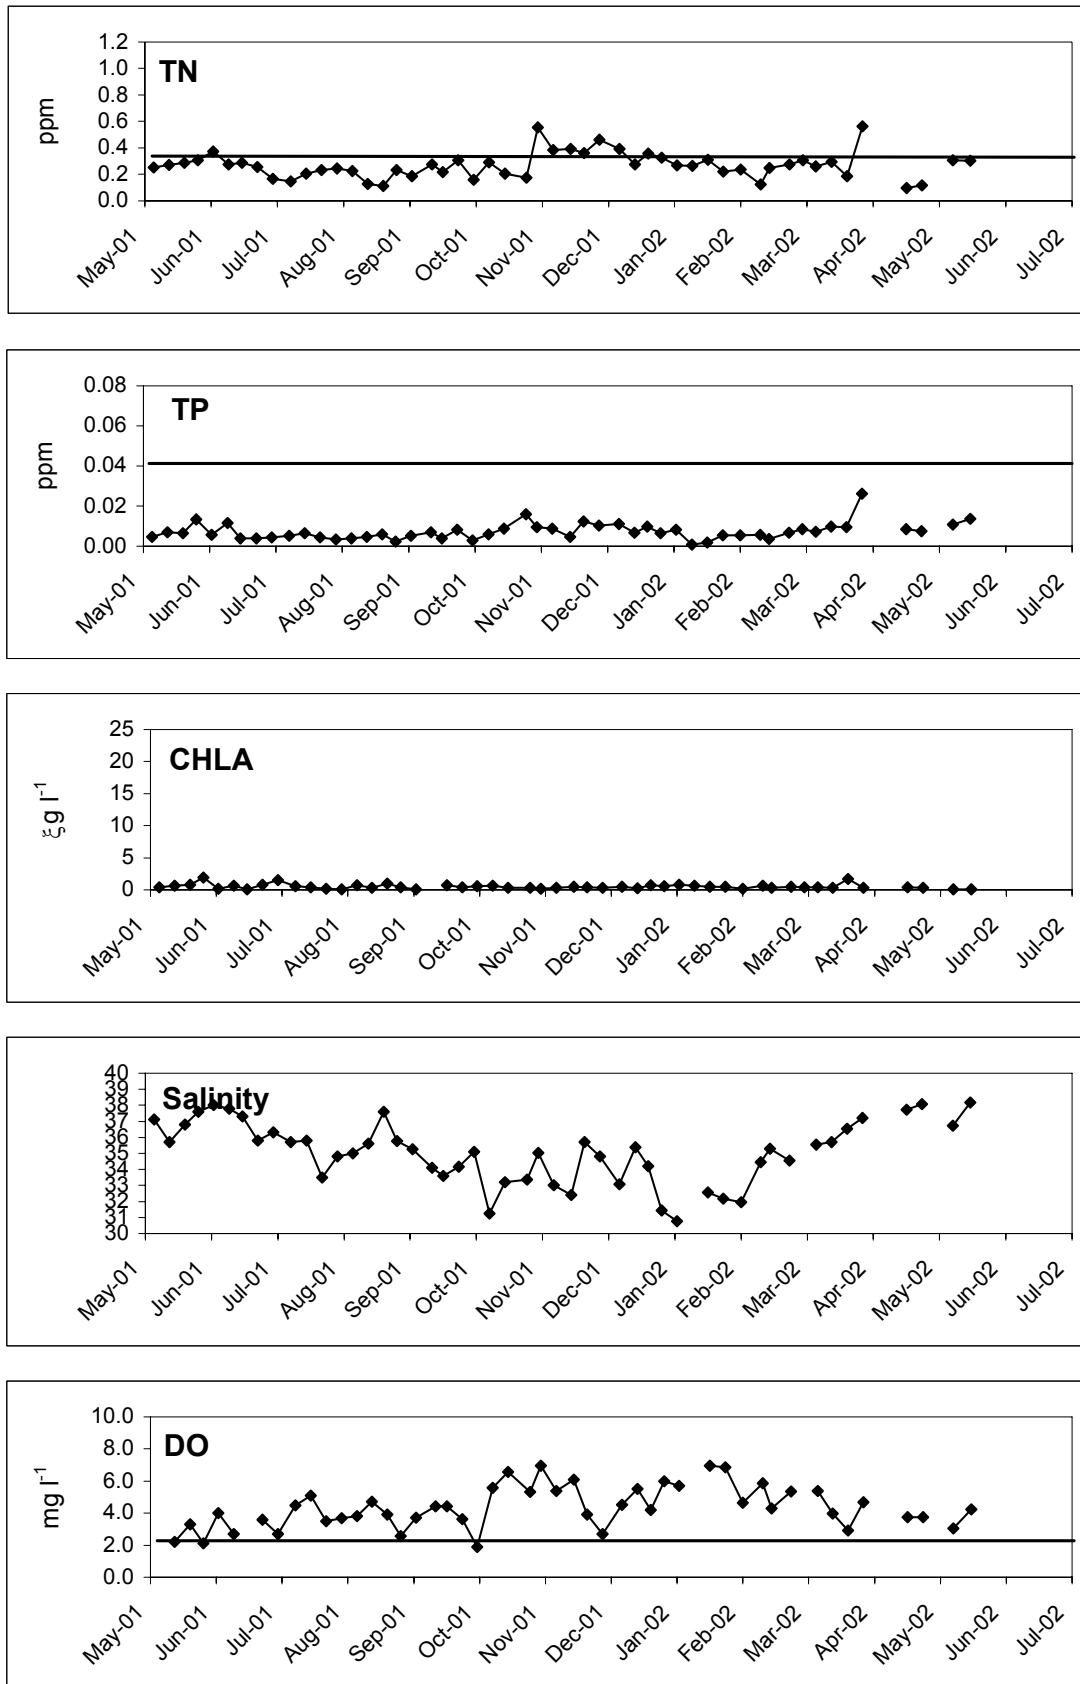
Figure 14

Sta.4 - Mouth of the 100th Street Canal

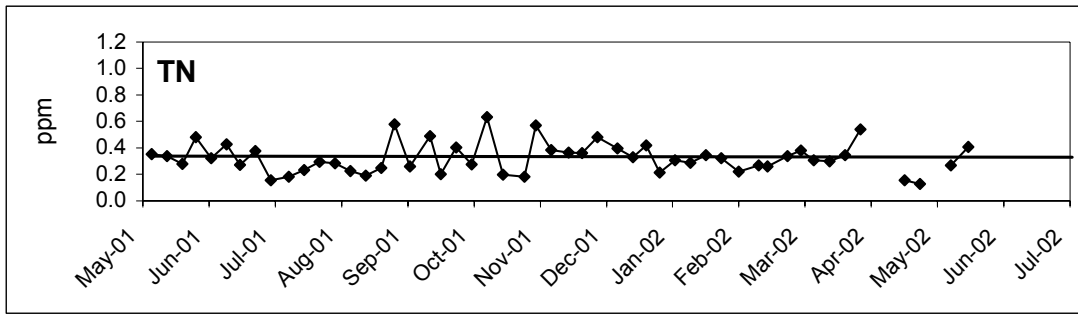
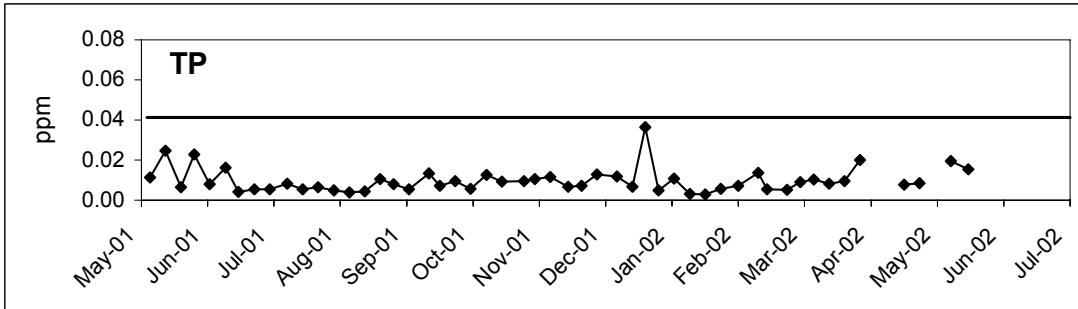
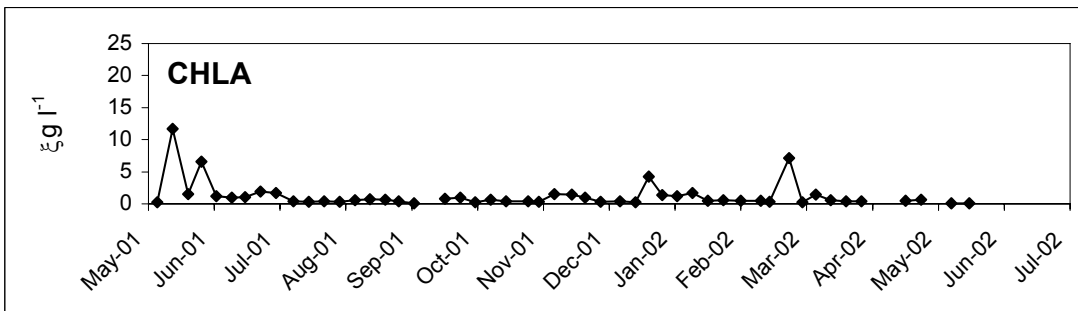
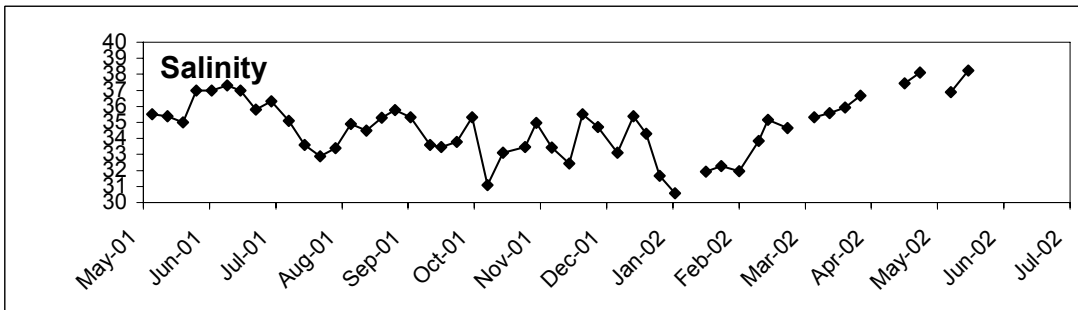
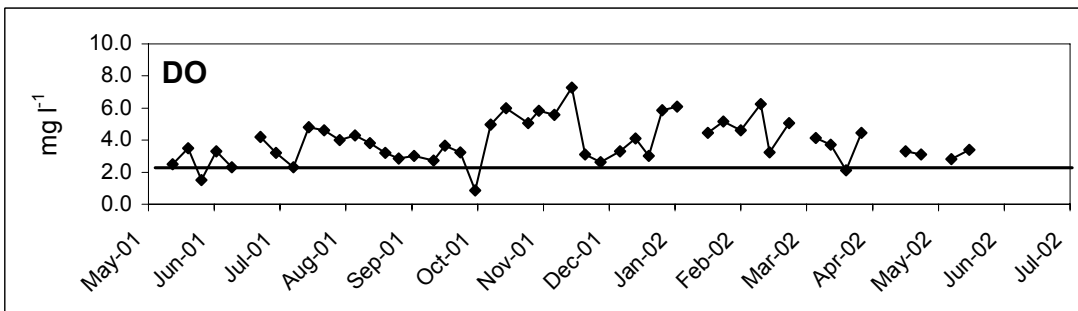
Figure 15

Sta.5 - Head of the 100th Street Canal

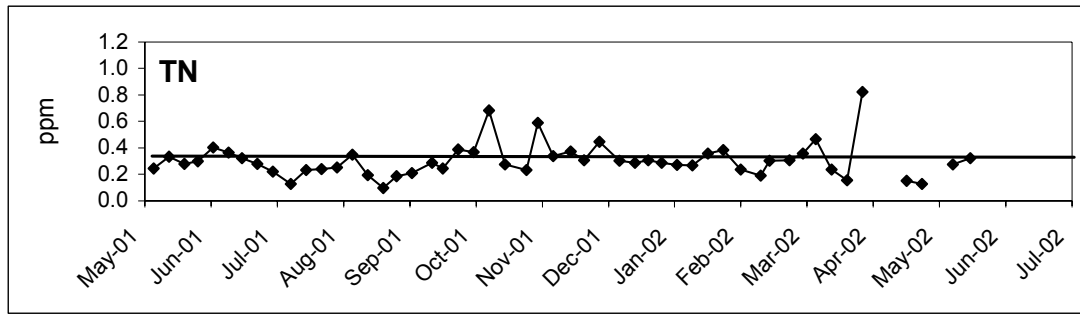
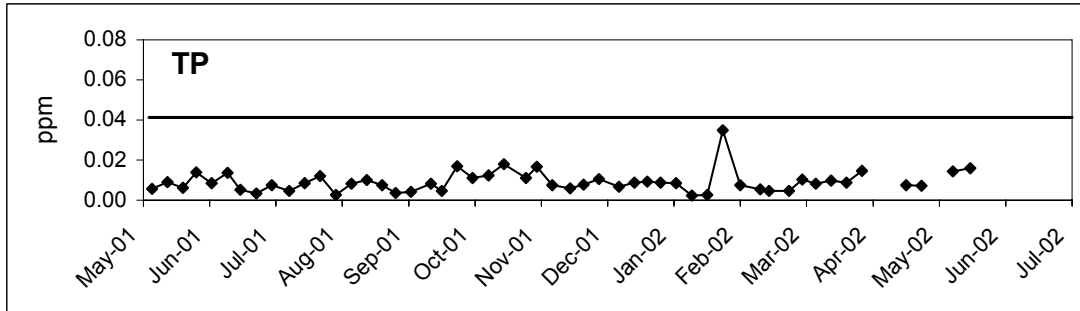
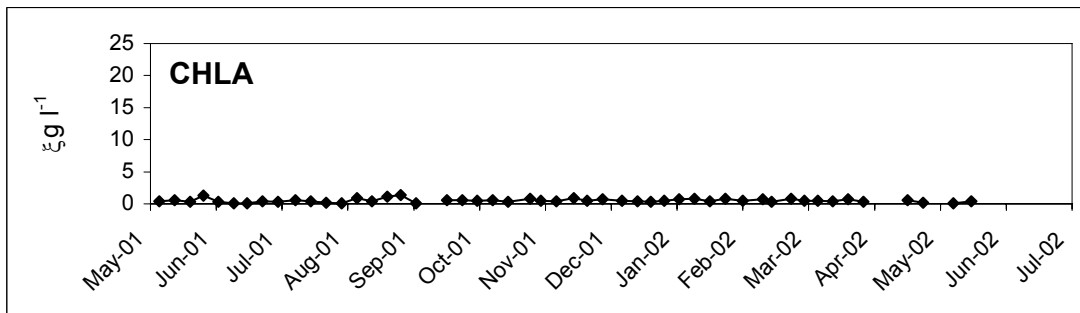
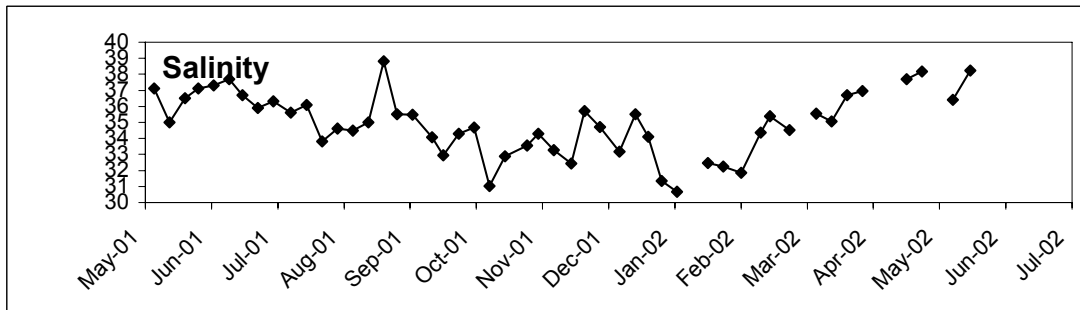
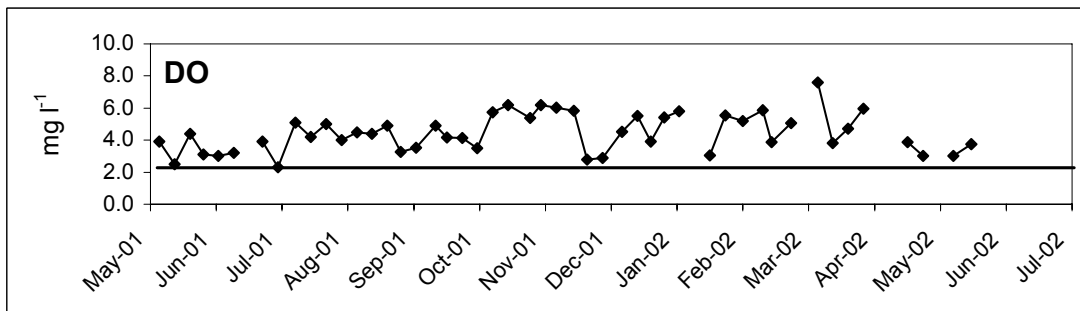
Figure 16

Sta.6 - Mouth of the 97th Street Canal

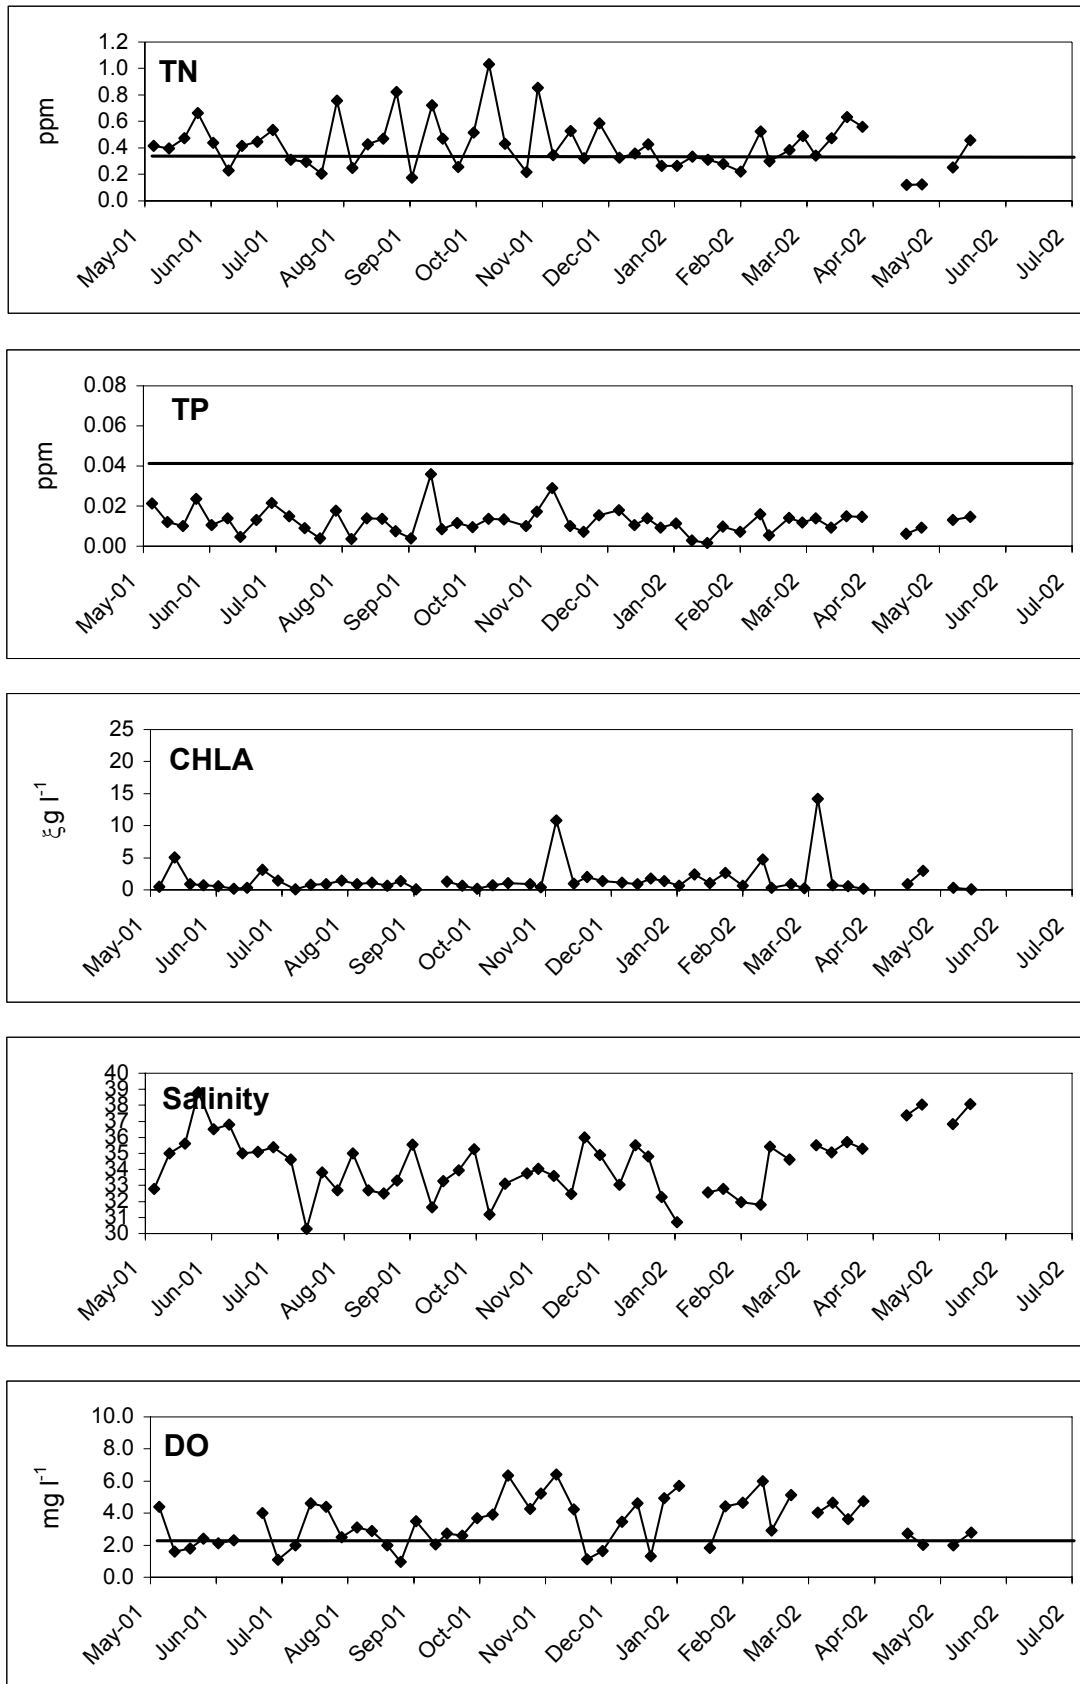
Figure 17

Sta.7 - Head of the 97th Street Canal

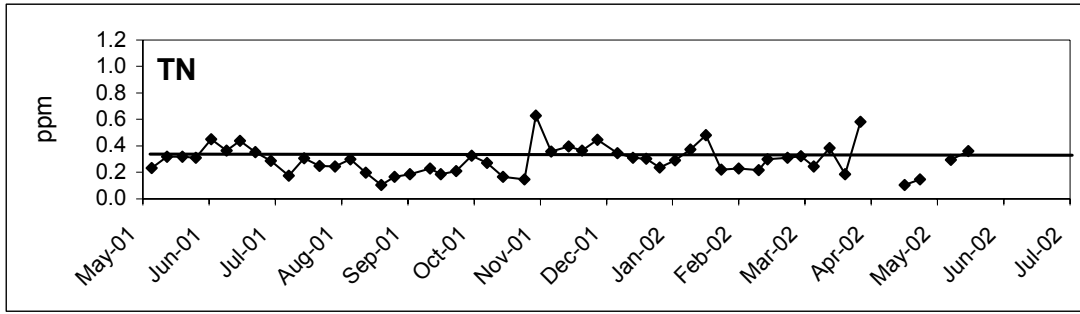
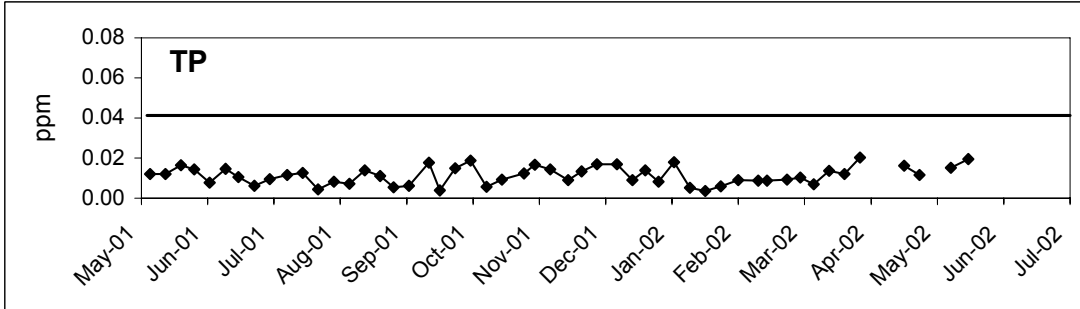
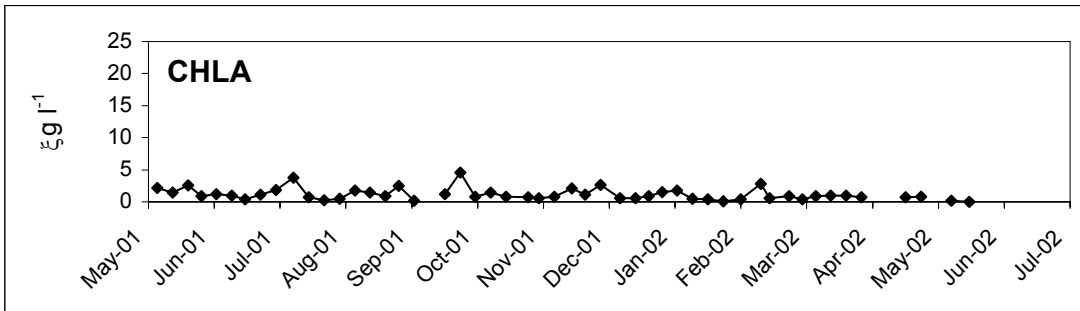
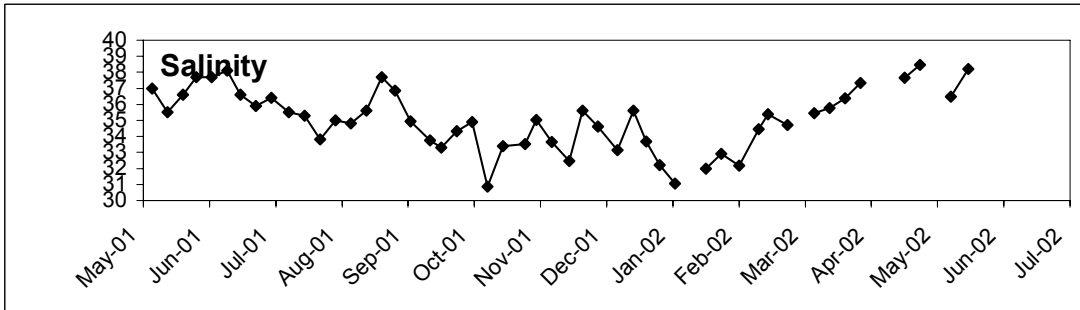
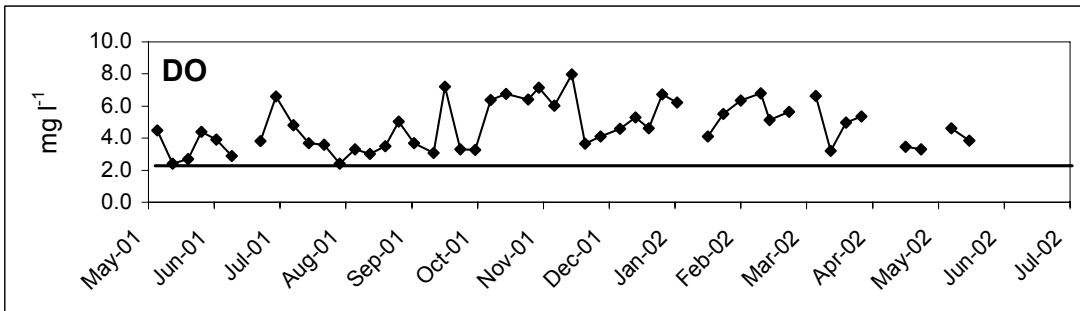
Figure 18

Sta. 8 - Mouth of the 91st Street Canal

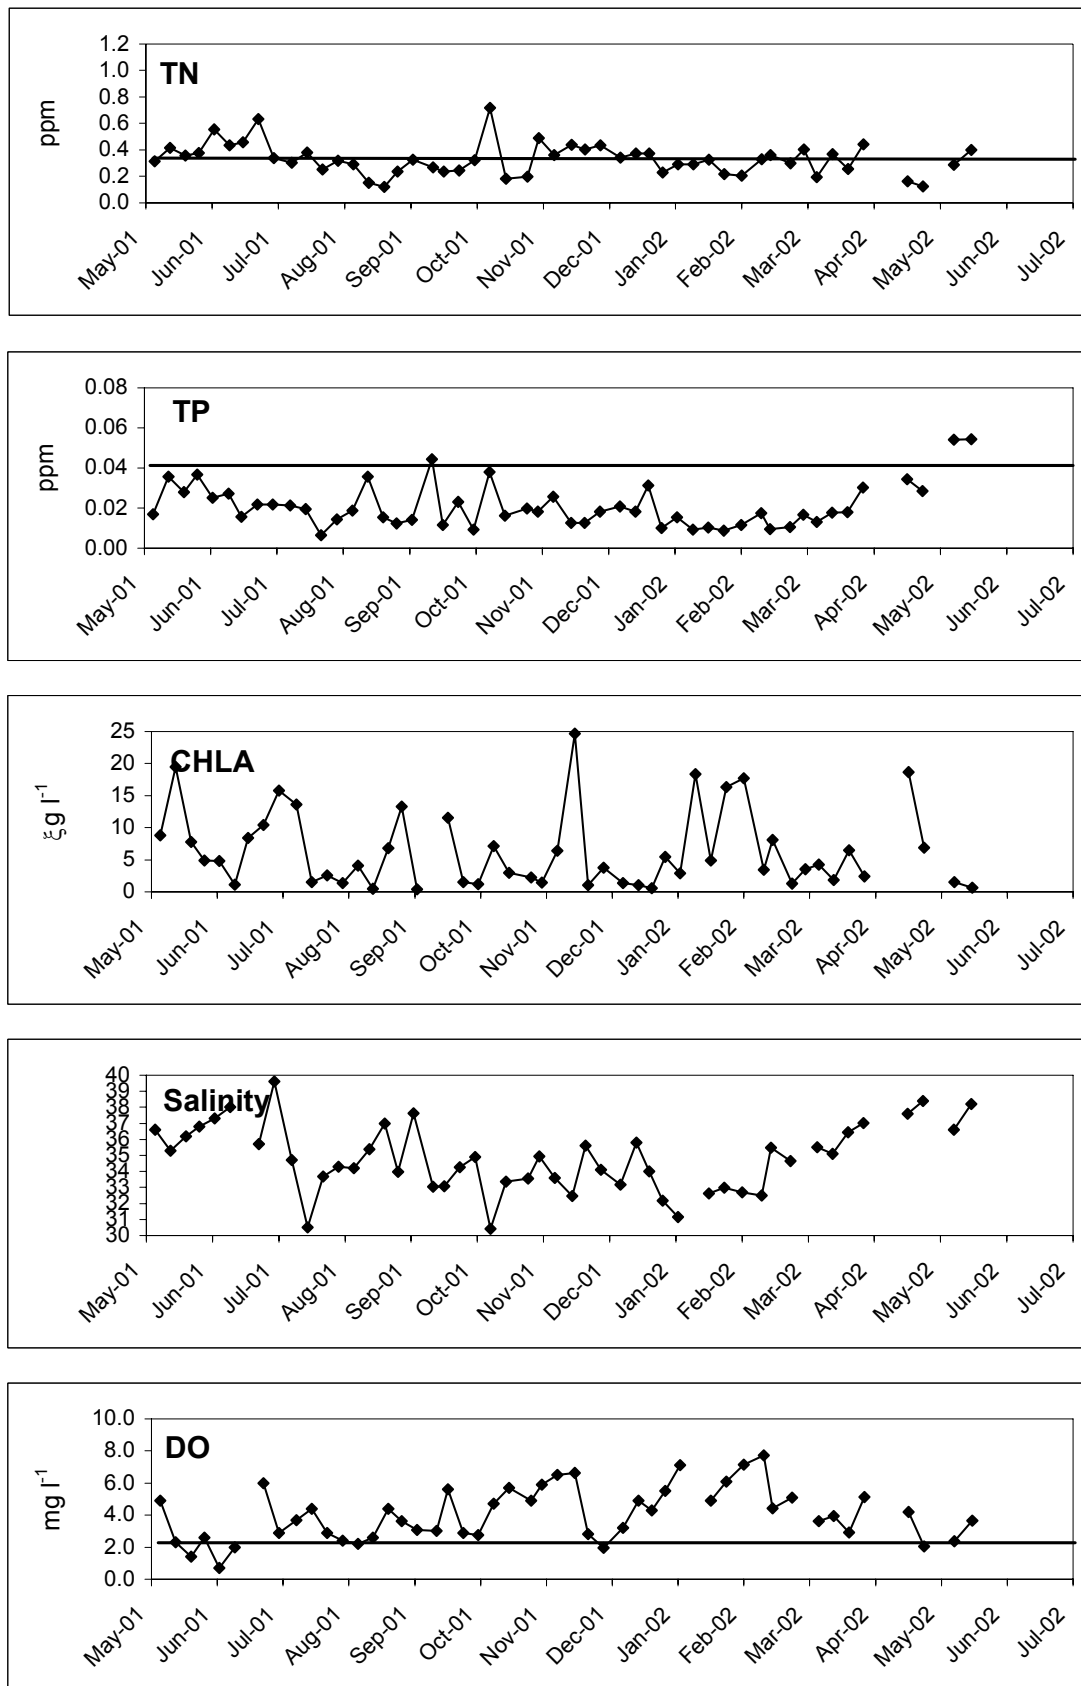
Figure 19

Sta. 9 - Head of the 91st Street Canal
